Weathertightness testing of a sample of Matrix 2 Rainscreen Cladding for PSP

N950/08/14075
13 AUGUST, 2008

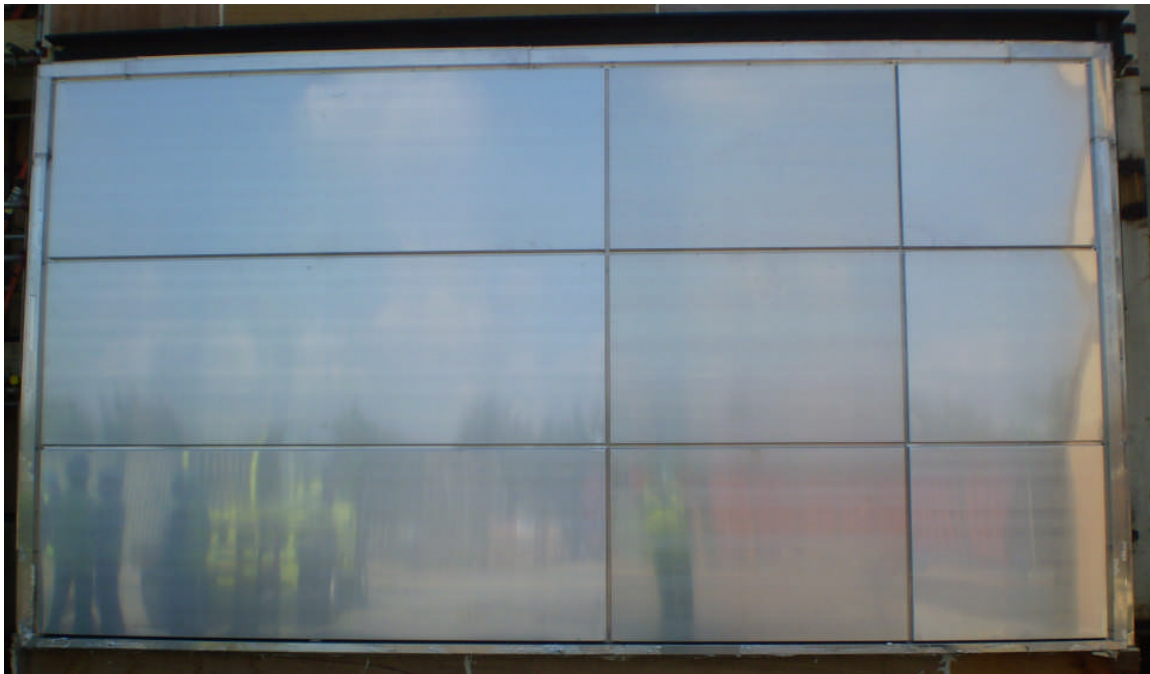
PHOTO 6050074

TEST SAMPLE ELEVATION

During the dismantling of the sample no discrepancies from the drawings were found.

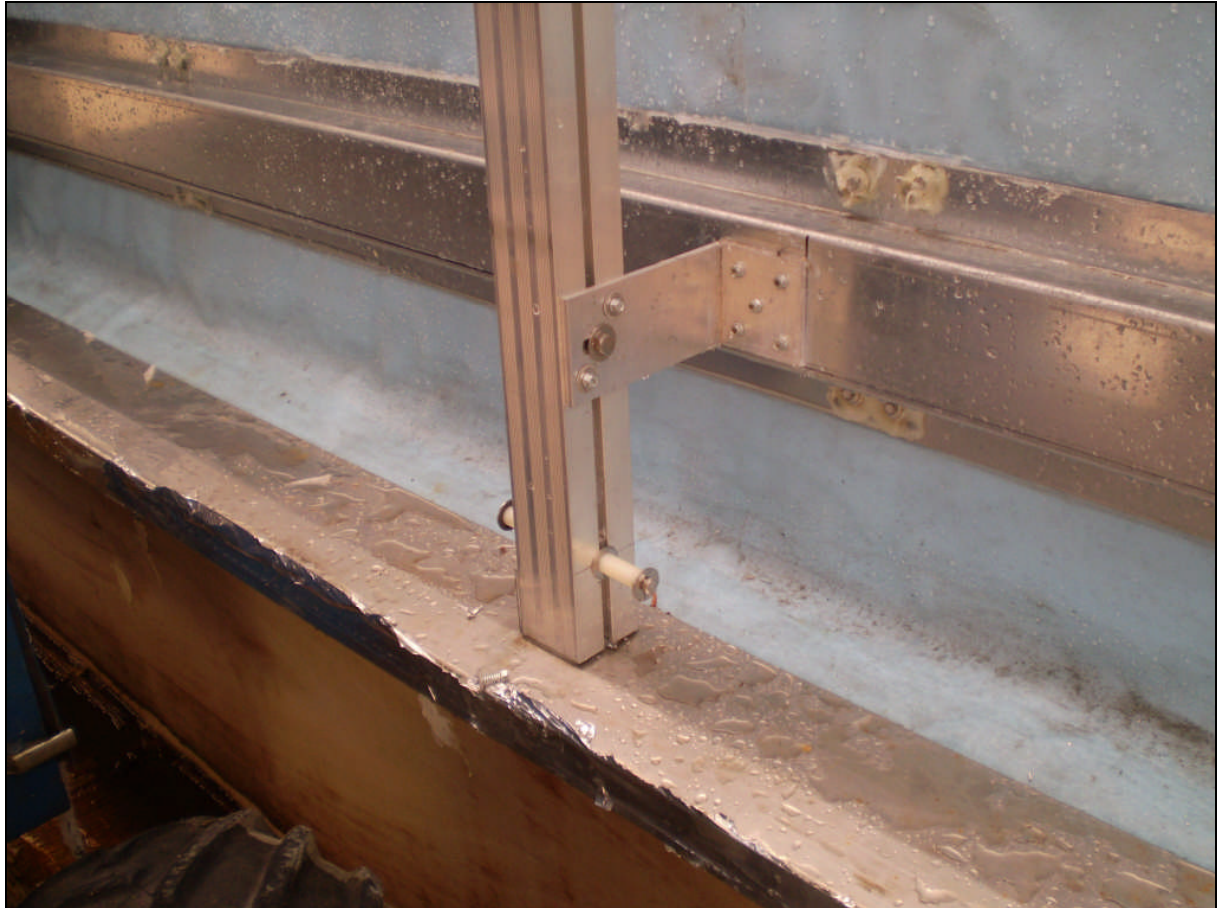
PHOTO P6050078

SUPPORT FRAME

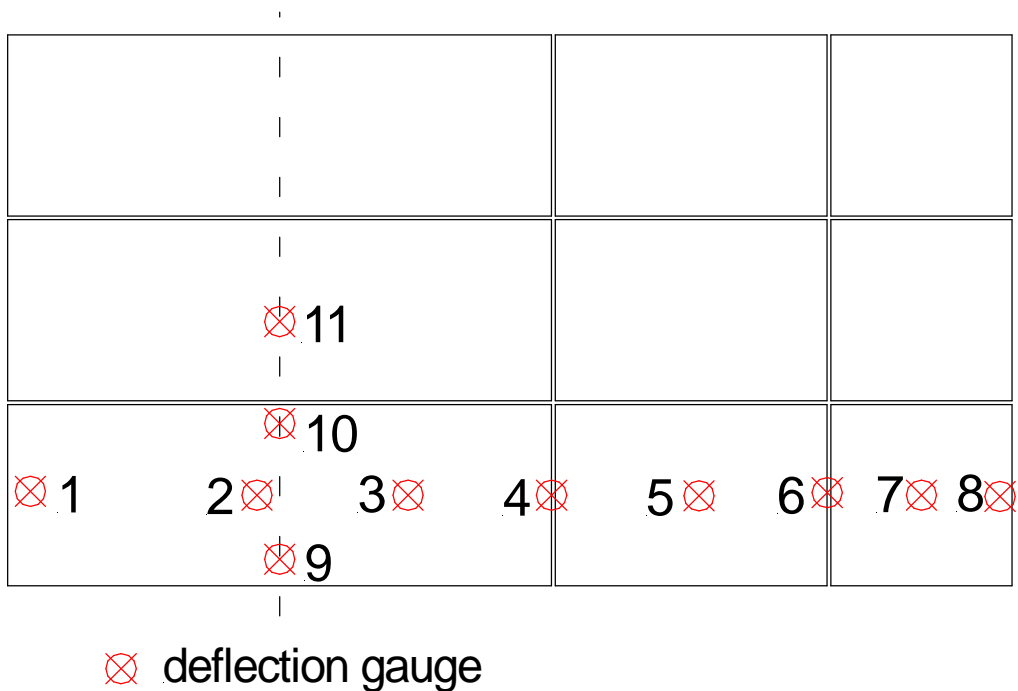
FIGURE 2

The deflections measured during the wind resistance test, at the positions shown in Figure 2, are shown in Tables 3 and 4.

Gauge number	Member	Pressure differential (Pa)	Measured deflection (mm)	Residual deformation (mm)
3	Back of panel	2400	2.9	0.4
		-2386	-2.8	-0.8
5	Back of panel	2421	17.7	0.3
		-2386	-13.8	-0.3
7	Back of panel	2421	19.2	0.0
		-2386	-15.2	-0.1
10	Back of support rail	2421	8.7	0.1
		-2386	-7.4	0.0

No damage to the test sample was observed.

No damage to the sample was observed.

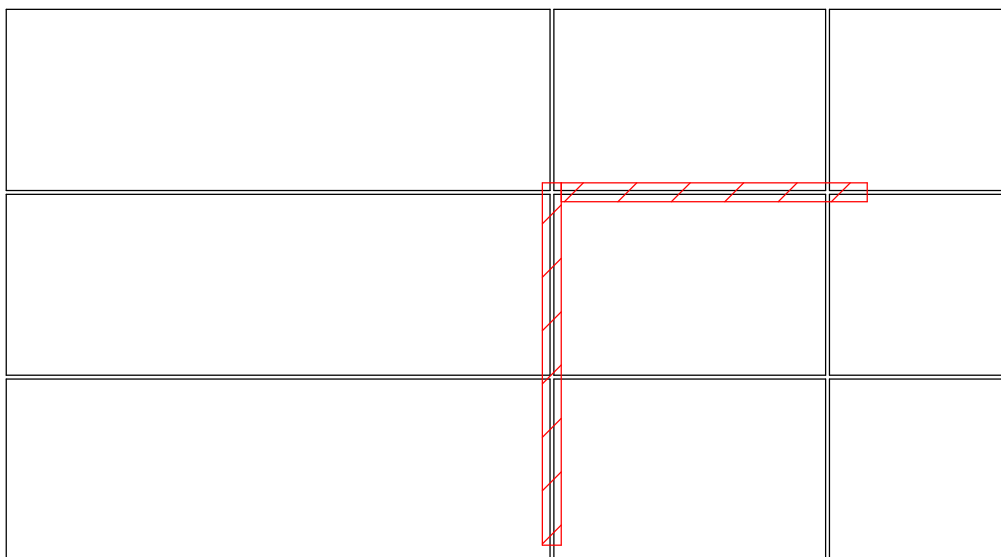
FIGURE 3

Few drops of water observed on viewing ports but mainly confined to back of rainscreen panels.

Minor leakage confined to back of rainscreen panels and rails.

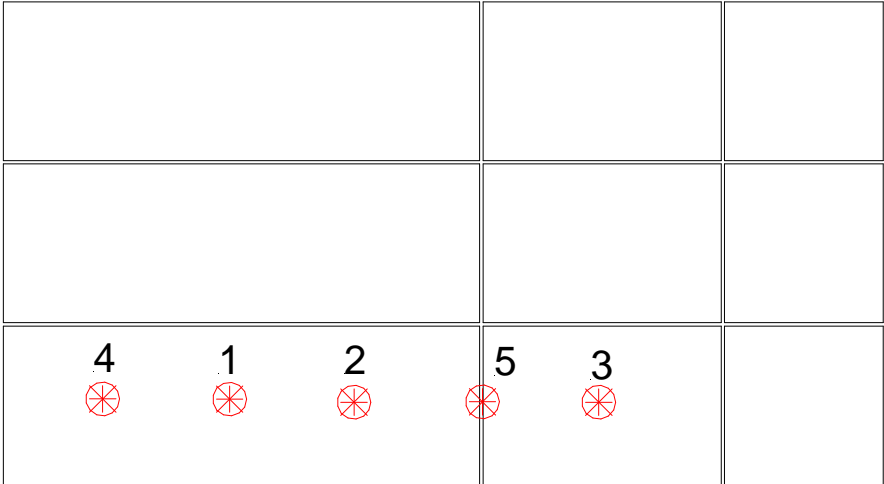
FIGURE 4

120 Nm soft body: No damage to the test sample was observed.

500 Nm soft body: No damage to the test sample was observed.

500 Nm soft body: Bottom of panel bent in but remained secure.

500 Nm soft body. Bottom of panel bucked but remained secure.

10 Nm hard body: Small indent observed – 0.5 mm deep.

10 Nm hard body: Small indent observed – 1 mm deep.

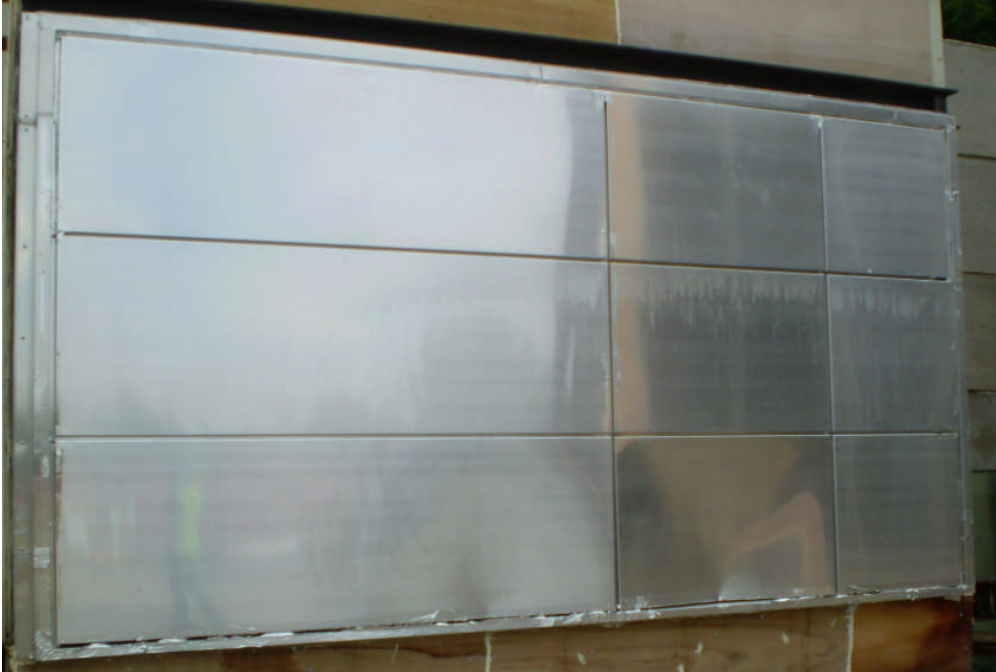
PHOTO 6050074

SAMPLE AFTER IMPACT TESTS
