Weathertightness testing of a sample of Matrix SFCM Rainscreen Cladding for PSP

N950/08/14067REV1
8 FEBRUARY, 2019

The test sample consisted of a Matrix SFCM rainscreen cladding system.

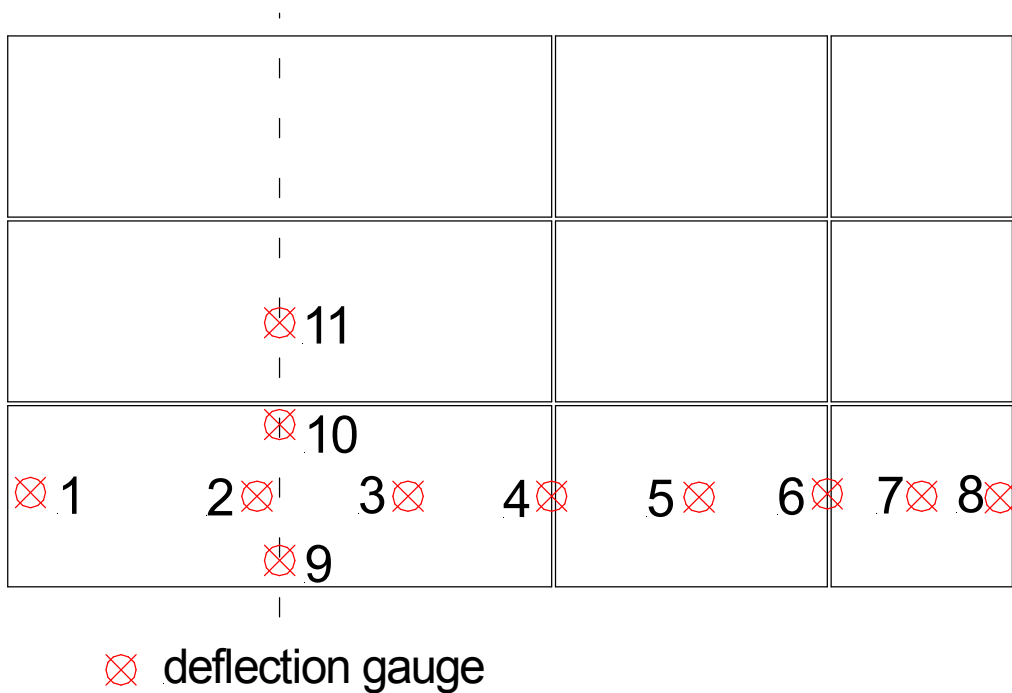
FIGURE 2

Gauge number	Member	Pressure differential (Pa)	Measured deflection (mm)	Residual deformation (mm)
3	Back of panel	2427	13.9	0.4
		-2397	-9.0	-0.2
5	Back of panel	2427	18.2	0.3
		-2397	-12.6	-0.4
7	Back of panel	2427	7.7	0.1
		-2397	-5.4	0.0
10	Back of vertical rail	2427	2.8	0.0
		-2397	-2.9	-0.1

No damage to the test sample was observed.

No damage to the sample was observed.

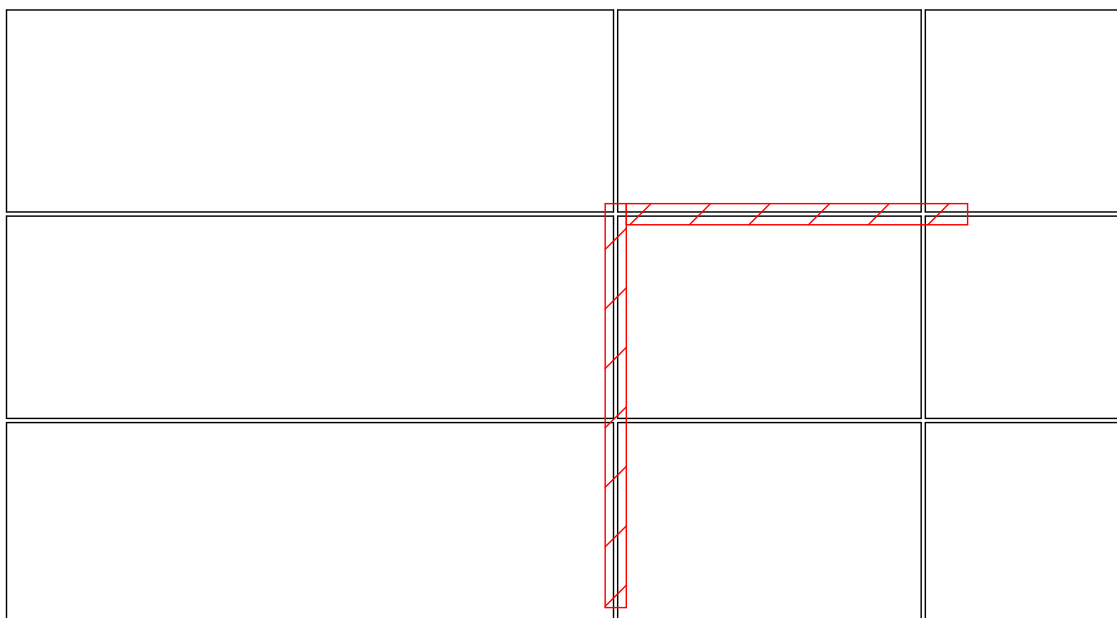
FIGURE 3

Minor leakage contained to the back of rain screen.

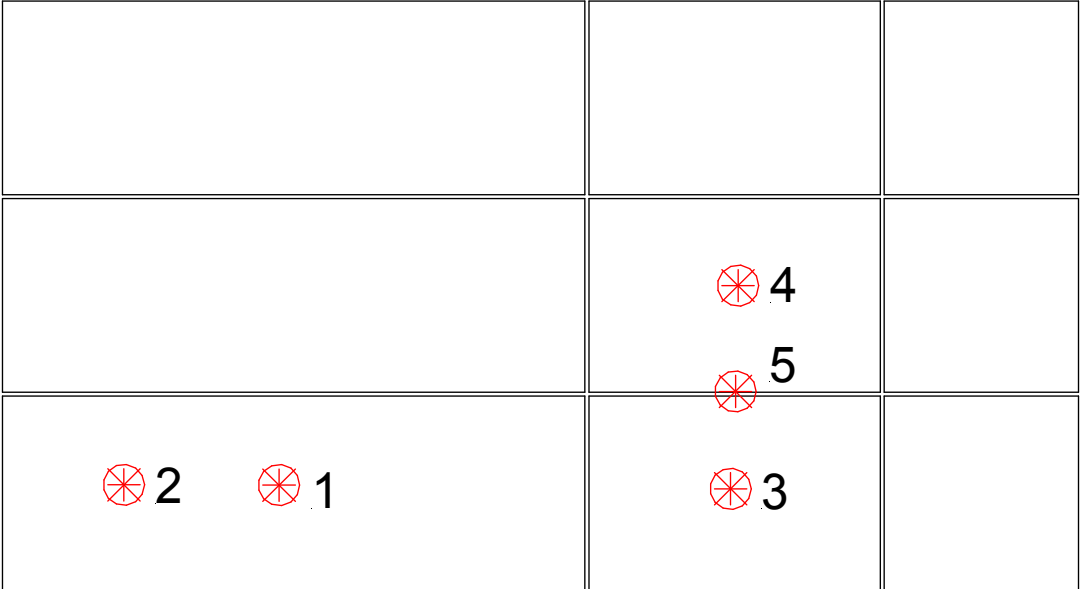
FIGURE 4

Location 1

120 Nm soft body. No damage to the sample was observed.

Location 2

350 Nm soft body. Small indent in panel observed.

500 Nm soft body. Crease in top of panel, larger indent.

Location 3

500 Nm soft body. Larger indent in panel. Top creased.

Location 4

3 Nm hard body. Small indent in panel observed.

Location 5

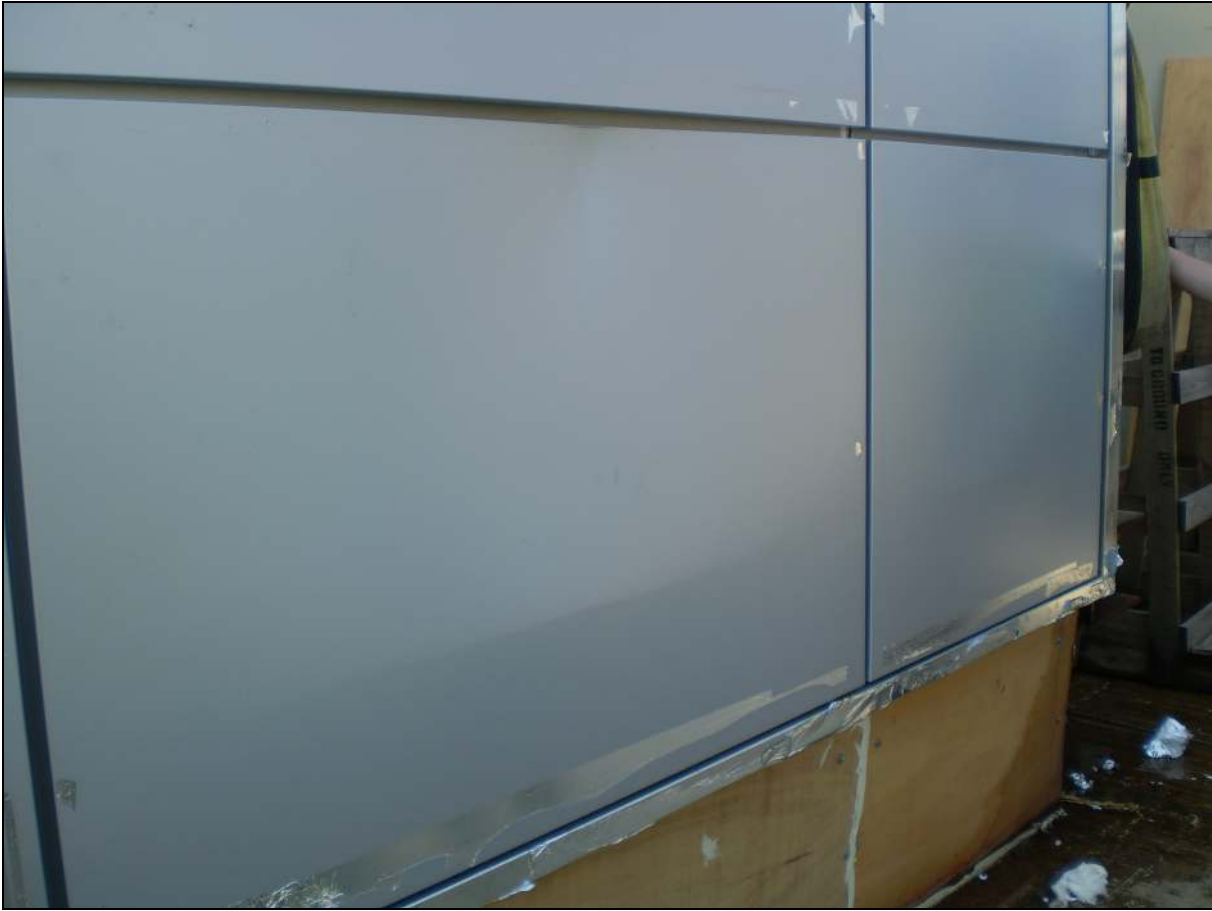
PHOTO 5120070

PANEL AFTER IMPACT TEST
